# YOSEMITE NATURE NOTES

VOLUME XXXVI · NUMBER 11

NOVEMBER 1957

## SAVING THE WAWONA COVERED BRIDGE

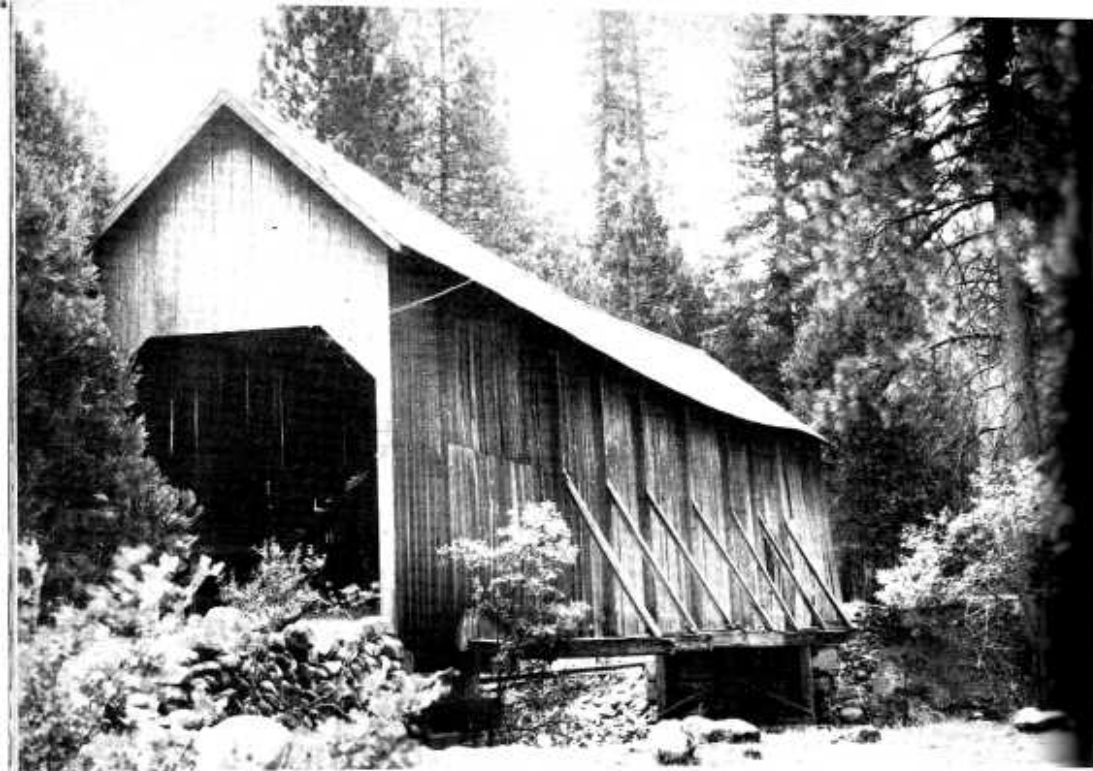
In 1955 the bridge was beginning to sag.

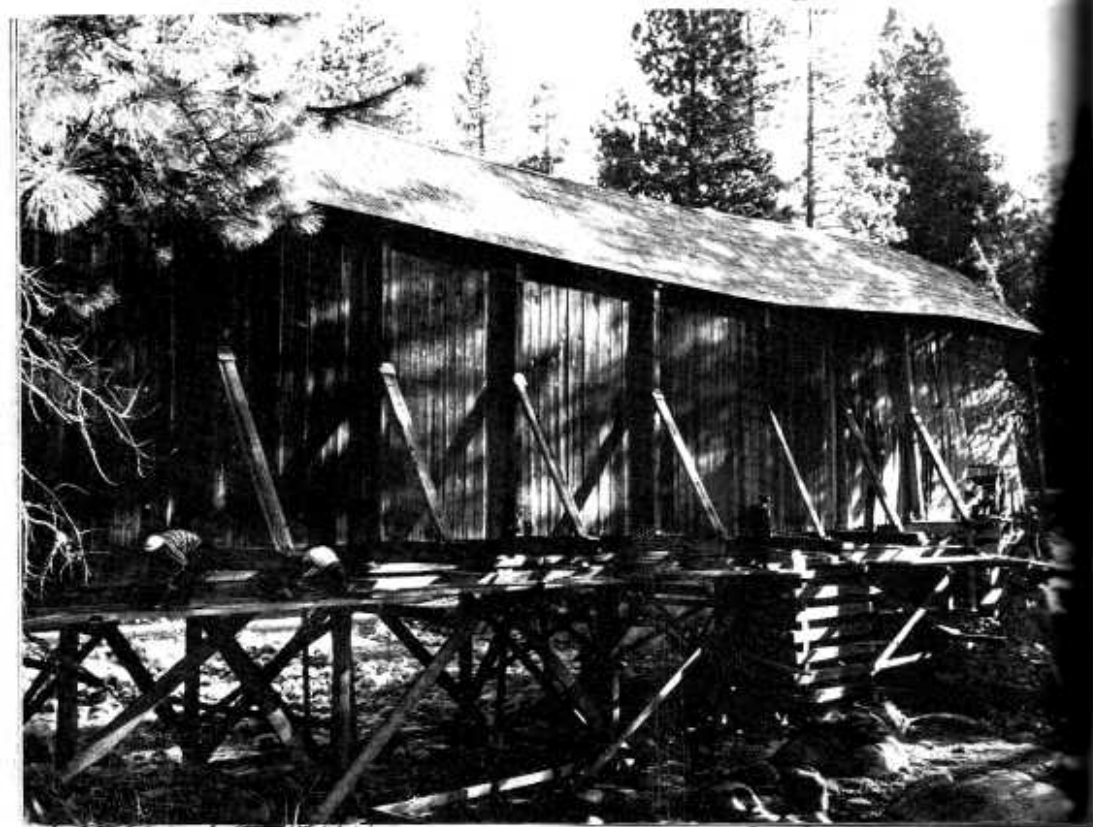
After the flood of 1955 cribbing saved the bridge.

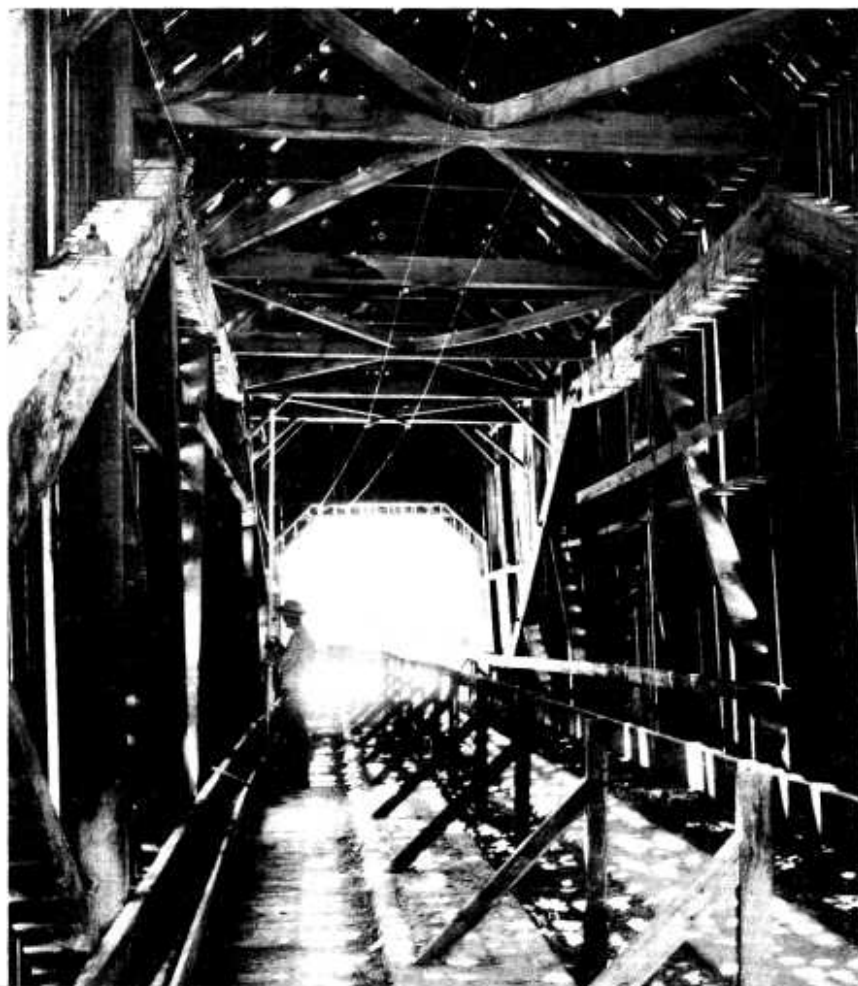
Careful measurements were made.

After careful measurements had been taken, the bridge was dismantled. All rotted timbers and materials were discarded and all salvageable wood was carefully saved. To facilitate the removal of the shingles, about 14 bundles of 20% dynamite were strung beneath the roof, then detonated. The blast removed the shingles neatly and loosened the nails so that they could be pulled out easily.

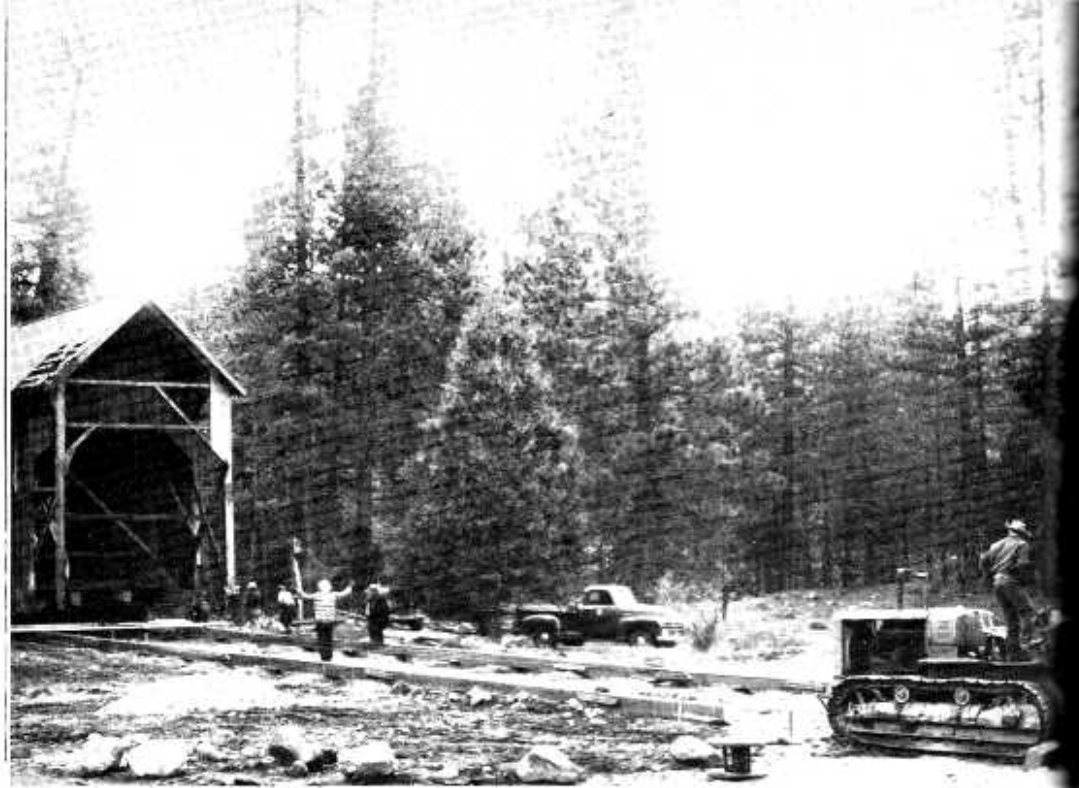
The bridge moved smoothly ashore.

The first and most urgent step was to pull the bridge over to the north bank before the flood season began. To do this, it was jacked up and a cribbing built of wooden beams placed beneath it. Pieces of 3-inch pipe were placed between wooden tracks and the lower chords to serve as rollers. Blocks and cables were rigged and the winch on a caterpillar tractor pulled the old bridge to safety on November 29, 1956.

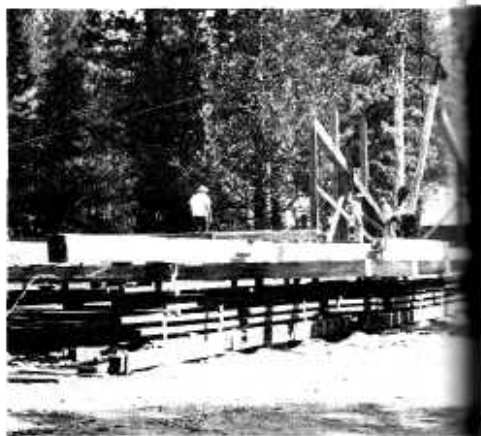
Replacing the timbers called for special skills.  
—Udell 119B

The reconstruction of the bridge took place on the north bank of the river. New timbers were hand hewn from ponderosa pine and the trusses were assembled on steel "I" beams

(steel beams whose cross-section resembles the letter "I"), which were to serve as "tracks" when the bridge was pulled back into place. To guard against water, all joints were made watertight so that moisture could not invade them and provide a suitable habitat for fungi which would cause

rotting, one of the major factors contributing to the weakening of the old bridge. Paper and sealing material were placed between all timbers. This plus the weight of the timbers produced a watertight seal.

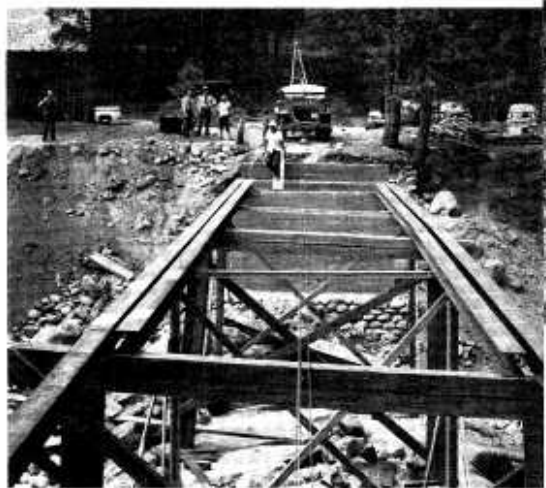
A "track" was made to pull the bridge back into place.

siding, flooring and shingles), the bridge was pulled back into place. Steel "I" beams were placed across the two permanent and two temporary abutments, level with the "I" beams on which the bridge was

resting. These were then welded together forming one continuous "track". The bridge was then raised and three inch pipe was placed between the lower chords and the track so that the restored bridge could be pulled back into place just as the old bridge had been pulled to safety. After the bridge had been pulled back into position, an operation which lasted about 5 hours, it was once more jacked up, the pipe and "I" beams were removed, and it was lowered onto its abutments, never, it is hoped, to be moved again.

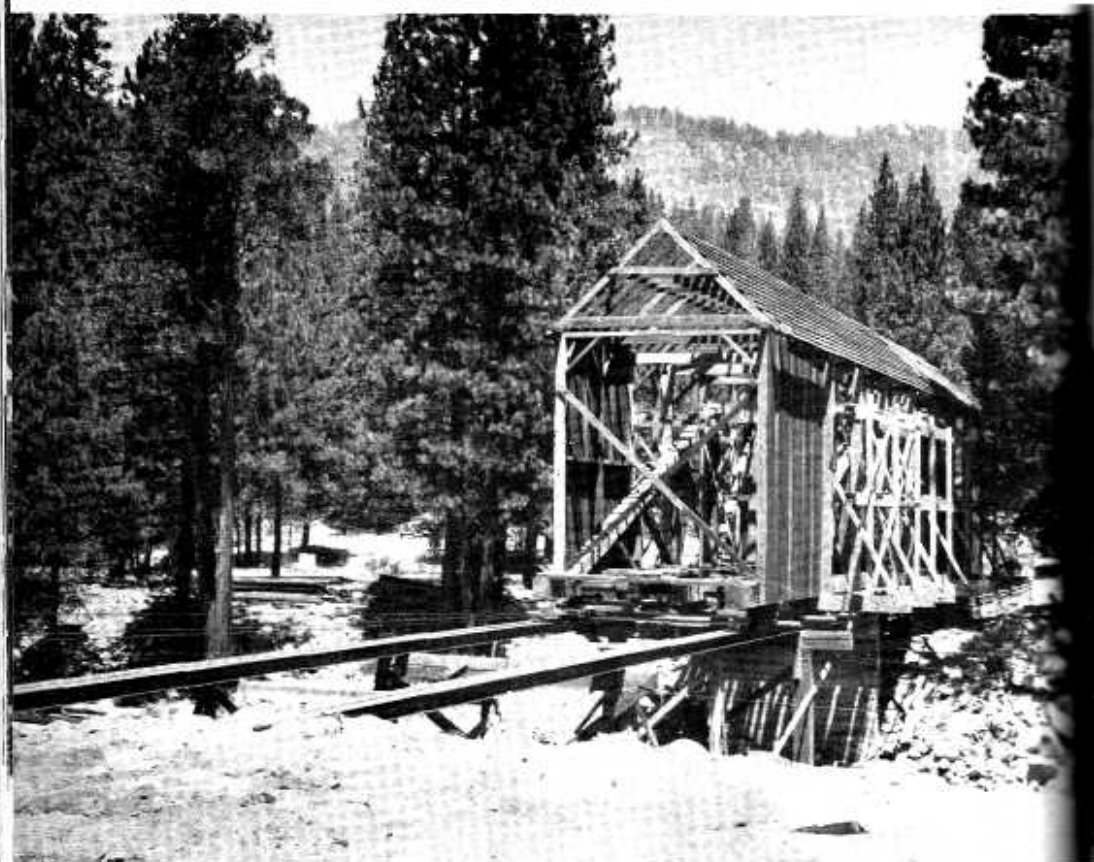
With gentle easing the bridge came back.

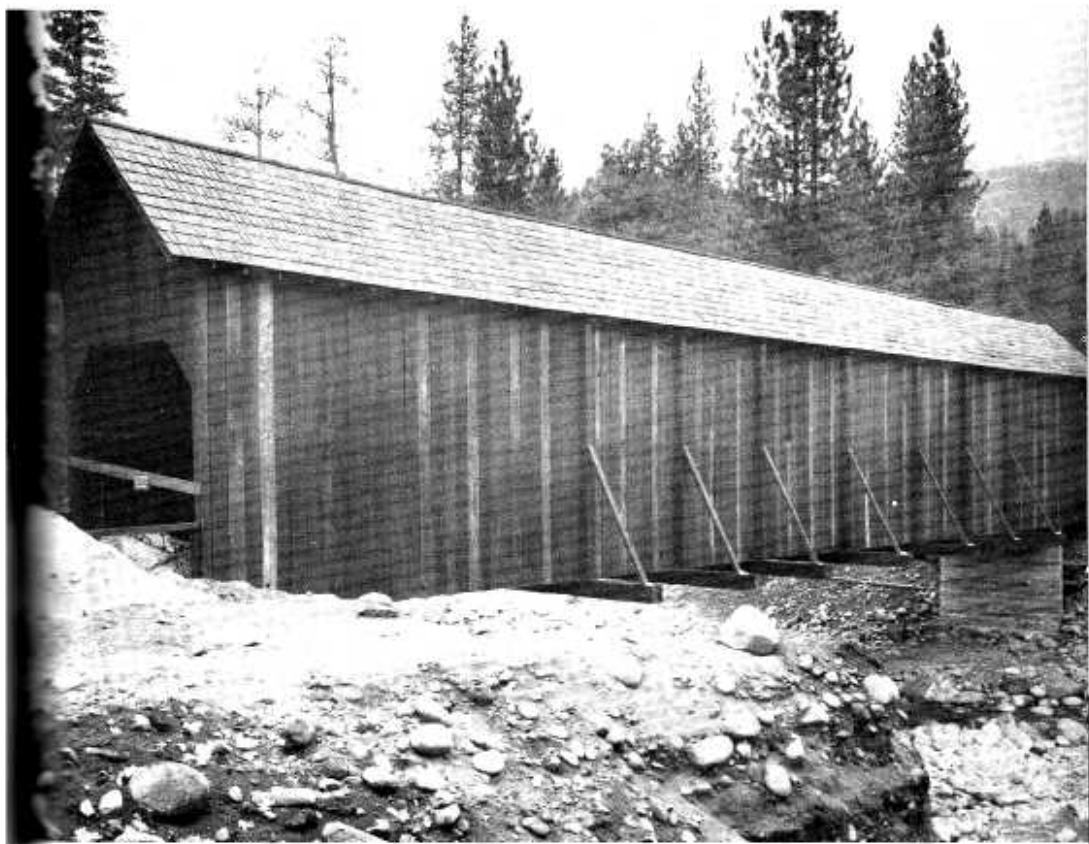
The bridge as it appears today. Only rock work and fill remain to complete the job.

Now with the siding, flooring, and shingles in place, the Wawona Covered Bridge stands again. It stands solidly, with no temporary piers to help support it. It stands true with no sag or lean. Now today's children and after them their children, can see
